Rupture of endotracheal tube cuff during robot-assisted endoscopic thyroidectomy

-A case report-

Department of Anesthesiology and Pain Medicine, ¹Seoul National University Hospital, ²National Medical Center, Seoul, ³Seoul National University Bundang Hospital, Seongnam, Korea

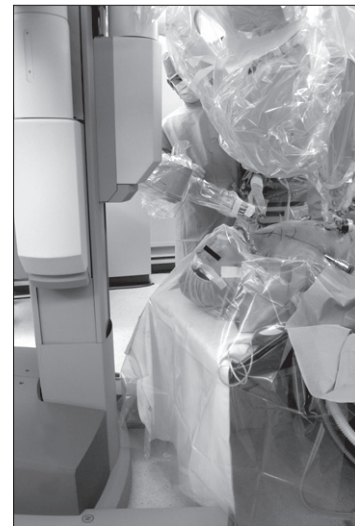
Fig. 2. Arrangement of the robot-manipulator is shown. The access to the patient's airway is limited once the robot arms are engaged.

into the patient via the bilateral axillary breast approach (Fig. 1) [2]. The CO₂ insufflation pressure was maintained at 6 cmH₂O throughout the procedure. Two hours after commencing the operation, the tidal volume decreased abruptly to 183 ml with an inspiration pressure set to 17 cmH₂O, and the bellows of the ventilator was not filled adequately. The hemodynamic variables were not changed. Controlled ventilation was switched immediately to manual ventilation and the oxygen flow was increased. The pilot balloon of the endotracheal tube was inflated but the anesthetic bag was not filled completely. Reintubation was planned under the suspicion of a tracheal injury and a rupture of the endotracheal tube cuff. An attempt was made to move the robot manipulator with arms away from the patient's head to make space for reintubation but it could not be moved unless the robot arms were removed from the patient (Fig. 2). An attempt was made to replace the ruptured

Although the risk of cardiopulmonary emergencies is not increased in robot-assisted procedures, their treatment is more complicated. Once the robot-manipulator is engaged, the position of the operating table cannot be changed without removing the robot from the patient's side. Removing the robot requires disengagement of the instruments and camera from the robot arms, unlatching the arms from the trocars, and then backing the robot away from the patient [1]. In our case, reintubation was attempted in the small space between the patient head and robot-manipulator without moving the robot away from the patient because a difficult airway was not expected. However, if a difficult airway is expected, the robot must be removed as quickly as possible to allow unimpeded access to the airway.

Adequate workspace for the anesthesiologist after the robot is brought into position is another concern. This problem should be solved by turning the head of the bed 30° to the robot's side, which allows the anesthesiologist unimpeded access to one side

of the head and the un-tucked arm [1]. In our case, we asked the surgical team to turn the head of the bed 30° to the robot's side for the subsequent robot-assisted operation, but they insisted that the robot-manipulator with arms should be located in line with the arm holding the 3D camera. This parallel arrangement of the robot-manipulator with the patient makes it difficult to prepare adequate workspace for the anesthesiologist.

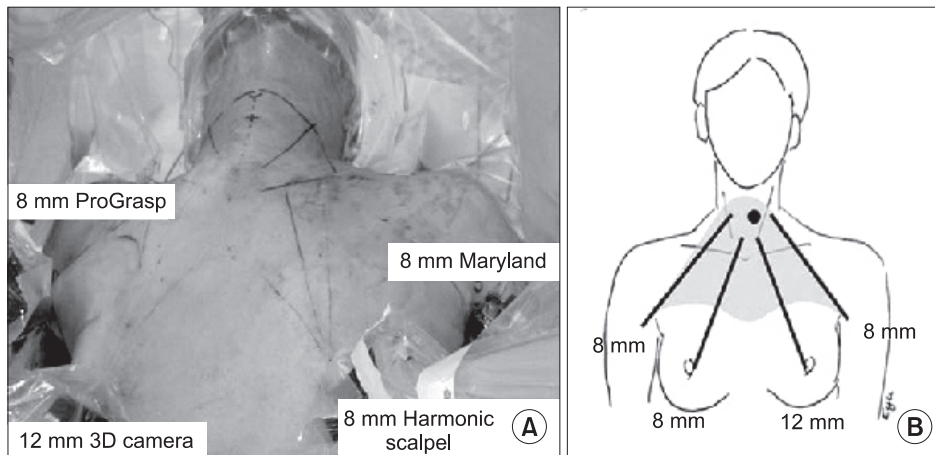
Fig. 1. A photographic (A) and schematic (B) illustration of the ports and paths of the instruments in bilateral axillary breast approach technique in robot-assisted endoscopic thyroidectomy is shown. (A) 8 mm ProGrasp forceps; 12 mm 3D camera; 8 mm Harmonic scalpel; 8 mm Maryland dissector (reproduced with permission from Fig. 1 in Lee et al. [2]).

The patient was placed in the supine position with head extension and neck flexion, and the robot arms were inserted

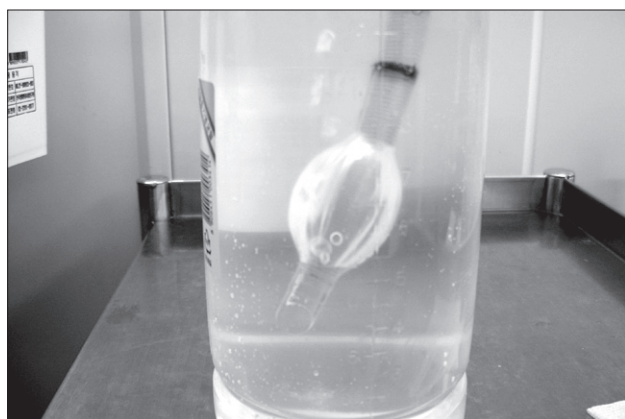
endotracheal tube with a new one using a tube exchanger at the right side of the patient's head due to the small space between the robot-manipulator and patient's head, but it was unsuccessful because the new tube was blocked at the vocal cord level. Therefore, the tube exchanger was removed and face mask ventilation was applied to the patient. The surgical team was asked to change the position of the operating table to make more space for reintubation. However, once the robot-manipulator is engaged, the position of the operating table cannot be changed without removing it from the patient. Removing the robot from the patient requires several steps and takes 1–2 minutes [1]. Therefore, reintubation was attempted in the small space between the patient's head and robot-manipulator without moving the robot away from the patient because the patient's airway was not difficult (Cormack grade I) during anesthetic induction. Fortunately, reintubation under direct laryngoscopy was successful at the first attempt while the surgery drape over patient's head was lifted up. The elapsed time was approximately 1–2 minutes for this process. During the reintubation, the peripheral oxyhemoglobin saturation (SpO_2) was not decreased from 99 or 100%, and the maximum end tidal CO_2 was 41 mmHg. The rupture of the endotracheal tube cuff was confirmed by observing air bubbles exiting from two points of 2–3 mm sized lacerations on the lower part of the balloon in water (Fig. 3).

Fig. 3. The air bubbles coming out of the lower parts of endotracheal tube cuff are seen. There were two points of 1–2 mm sized lacerations on lower part of the cuff.

The signs of tracheal injury during a thyroidectomy vary according to the laceration site. When the tracheal injury is below the endotracheal tube cuff, it can induce subcutaneous emphysema and pneumothorax due to positive ventilation [8]. However, the tracheal injury at the cuff level might cause a rupture of the endotracheal tube cuff, which can lead to mechanical ventilatory failure during anesthesia [9] and abrupt pneumothorax after extubation [10]. Above the cuff level, such an injury may not manifest any clinical signs but insufflated CO_2

When an injury to the trachea is suspected during surgery, a visual inspection of the operation field may miss small perforations. Instilling saline into the wound and checking for air leakage is recommended. A flexible bronchoscope can be used to confirm the injury. A chest X-ray was used to identify pneumothorax or pneumomediastinum, and computed tomography of the neck and chest may help localize the site of the perforation. In our case, the tracheal injury sites were neither visualized nor confirmed by saline instillation. However, the abrupt onset of ventilatory failure and the observation of two lacerations on the endotracheal cuff were sufficient to prove the tracheal injuries in this case.

For treatment, primary repair is the first choice [11,12]. A strap muscle can be rotated over and reinforce the repair. Conservative treatment is considered appropriate for small lacerations of the membranous trachea, less than one third of the circumference of the trachea or bronchus.
