## Internal leakage of oxygen flush valve

Department of Anesthesiology and Pain Medicine, Kangbuk Samsung Hospital, Sungkyunkwan University School of Medicine, Seoul, Korea

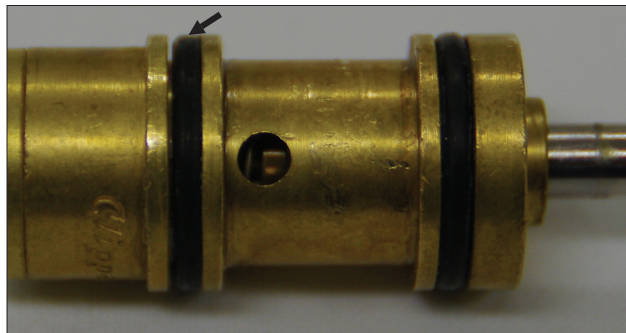
**Fig. 1.** An enlarged mechanical part of oxygen flush valve. We found the rubber of O-ring was worn out (arrow).

Determined to discard it, we disassembled the unit. As a result, as shown in Fig. 1, we discovered that the O-ring around the oxygen flush valve was worn out and that oxygen seemed to have been leaking in as a result. In other words, the oxygen flush valve continued to be partially activated. Then, it is supposed that the continuous inflow of oxygen may have diluted the inhaled anesthetic agent, lowering the level of concentration more than expected. Furthermore, the oxygen concentration indicated on the oxygen analyzer seems to have been assessed much higher than the setting.

Even though most anesthesia machines undergo periodic inspections, such routine check-ups do not always discover all leak sites in an anesthesia machine. Therefore, a manual checkout procedure should be mandatory for thorough inspection of the machine. Prior to initiating anesthesia, it is required to perform daily pre-use leak tests using the checklists for anesthesia equipment issued in 1993 by the United States Food and Drug Administration [1].
