# The tip fracture of the Coopdech bronchial blocker during insertion in the patient with lung surgery

Deokkyu Kim, Ji-Seon Son, Hyungsun Lim, Jun Ho Lee, and Eun Joo Jang

Department of Anesthesiology and Pain Medicine, Chonbuk National University Medical School and Hospital, Jeonju, Korea

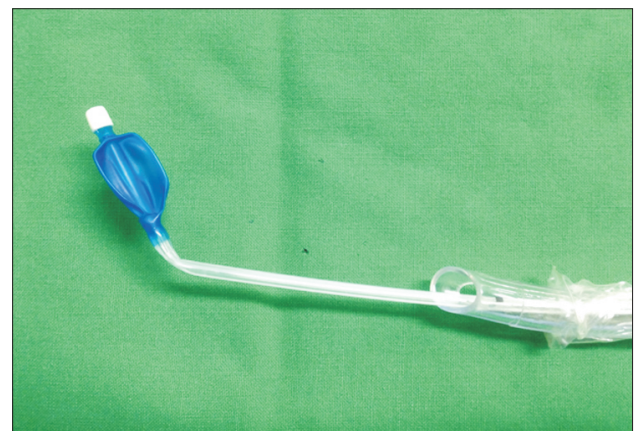
**Fig. 1.** The Coopdech bronchial blocker showing its fractured tip and the accompanying endotracheal tube.

right side, and then the bronchial blocker was pulled into the tracheal tube. The bronchial blocker was successfully removed without leaving behind any remnants. Consequently, the bronchial blocker that was removed revealed more marked angulation of the natural angle portion (Fig. 1). Then, a 35 Fr double-lumen tube was inserted instead of another Coopdech bronchial blocker for the fast progress of the operation. The surgery was performed successfully. The patient experienced no complications from this event.

In our patient, we performed repeated insertion into the left main bronchus under bronchoscopic guidance. Blind insertion may cause the tip fracture after withdrawing the pediatric fiberoptic bronchoscope. Venkataraju et al. [2] reported that partial fracture of the Coopdech bronchial tip occurred when attempting to place the bronchial blocker in the right main bronchus. They suspected that the angulated tip of the blocker may have been caught in the Murphy's eye of the tracheal tube. However, in our case, the cause of fracture was not accidental catching in the Murphy's eye of the tracheal tube.

We suggest that the Coopdech bronchial blocker should be inserted under continuous bronchoscopic guidance for the purpose of reducing the risk of tip fracture during its placement.
