Letter to the Editor

Korean J Anesthesiol 2020;73(1):77-78
<https://doi.org/10.4097/kja.19285>
pISSN 2005-6419 • eISSN 2005-7563

Point-of-care ultrasonography: a boon for early localization and retrieval of broken fragment of external jugular venous catheter

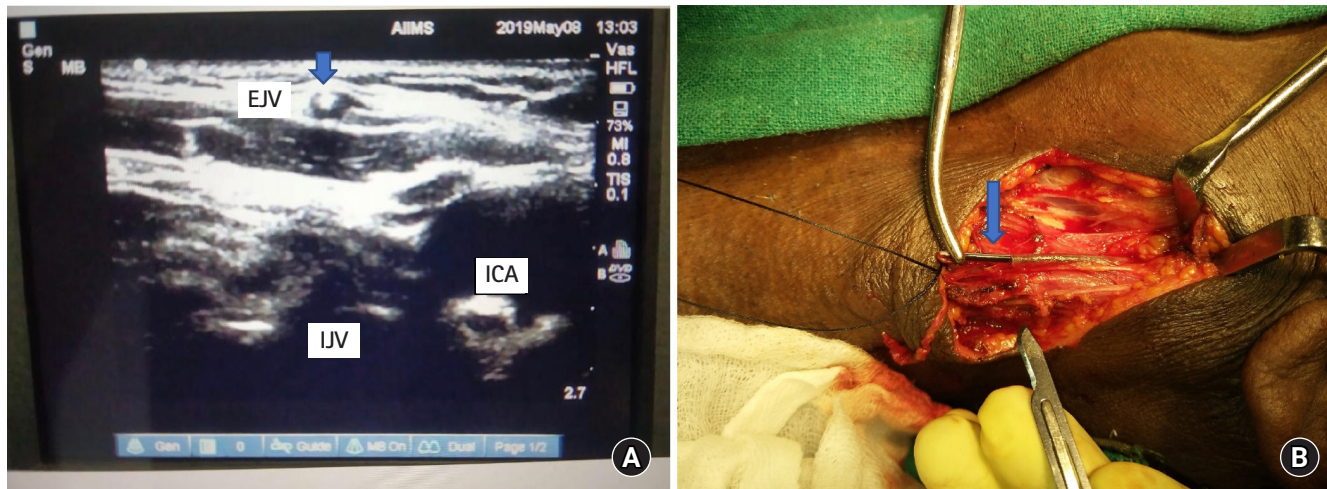
Fig. 1. (A) Out of plane ultrasound view of the neck, the 16-gauge intravenous catheter is seen as a hyperdense image (blue arrow) inside the external jugular vein (EJV). Internal jugular vein (IJV) and internal carotid artery (ICA) are visible in the background. (B) Surgical exposure of the EJV and removal of the broken part of the sheath of the 16-gauge catheter (blue arrow).

An 84-year-old male patient (written informed consent has been taken from the patient for publication) with diagnosis of pneumonia in the post-chemotherapy phase for acute myeloid leukemia was shifted to the intensive care unit for intermittent non-invasive ventilation. He had a 16-gauge external jugular venous catheter *in situ*, in view of difficult peripheral venous access. During removal, the catheter broke with the entire sheath inside the vein. Bedside POCUS in the intensive care unit was used to locate the catheter sheath (Fig. 1A). Surgical removal of the broken piece of the catheter was planned. Position of the fragment was re-confirmed by POCUS in the operation theatre just before retrieval, and was removed successfully under local anesthesia and monitored anesthesia care (Fig. 1B). Post-retrieval ultrasound was done to ensure the absence of remnants.
